# Performance maintenance of large PV installations

14. Nationale Photovoltaik-Tagung, 22. - 23. Februar 2016, Bern

Manuel Lanz, Prof. Urs Muntwyler

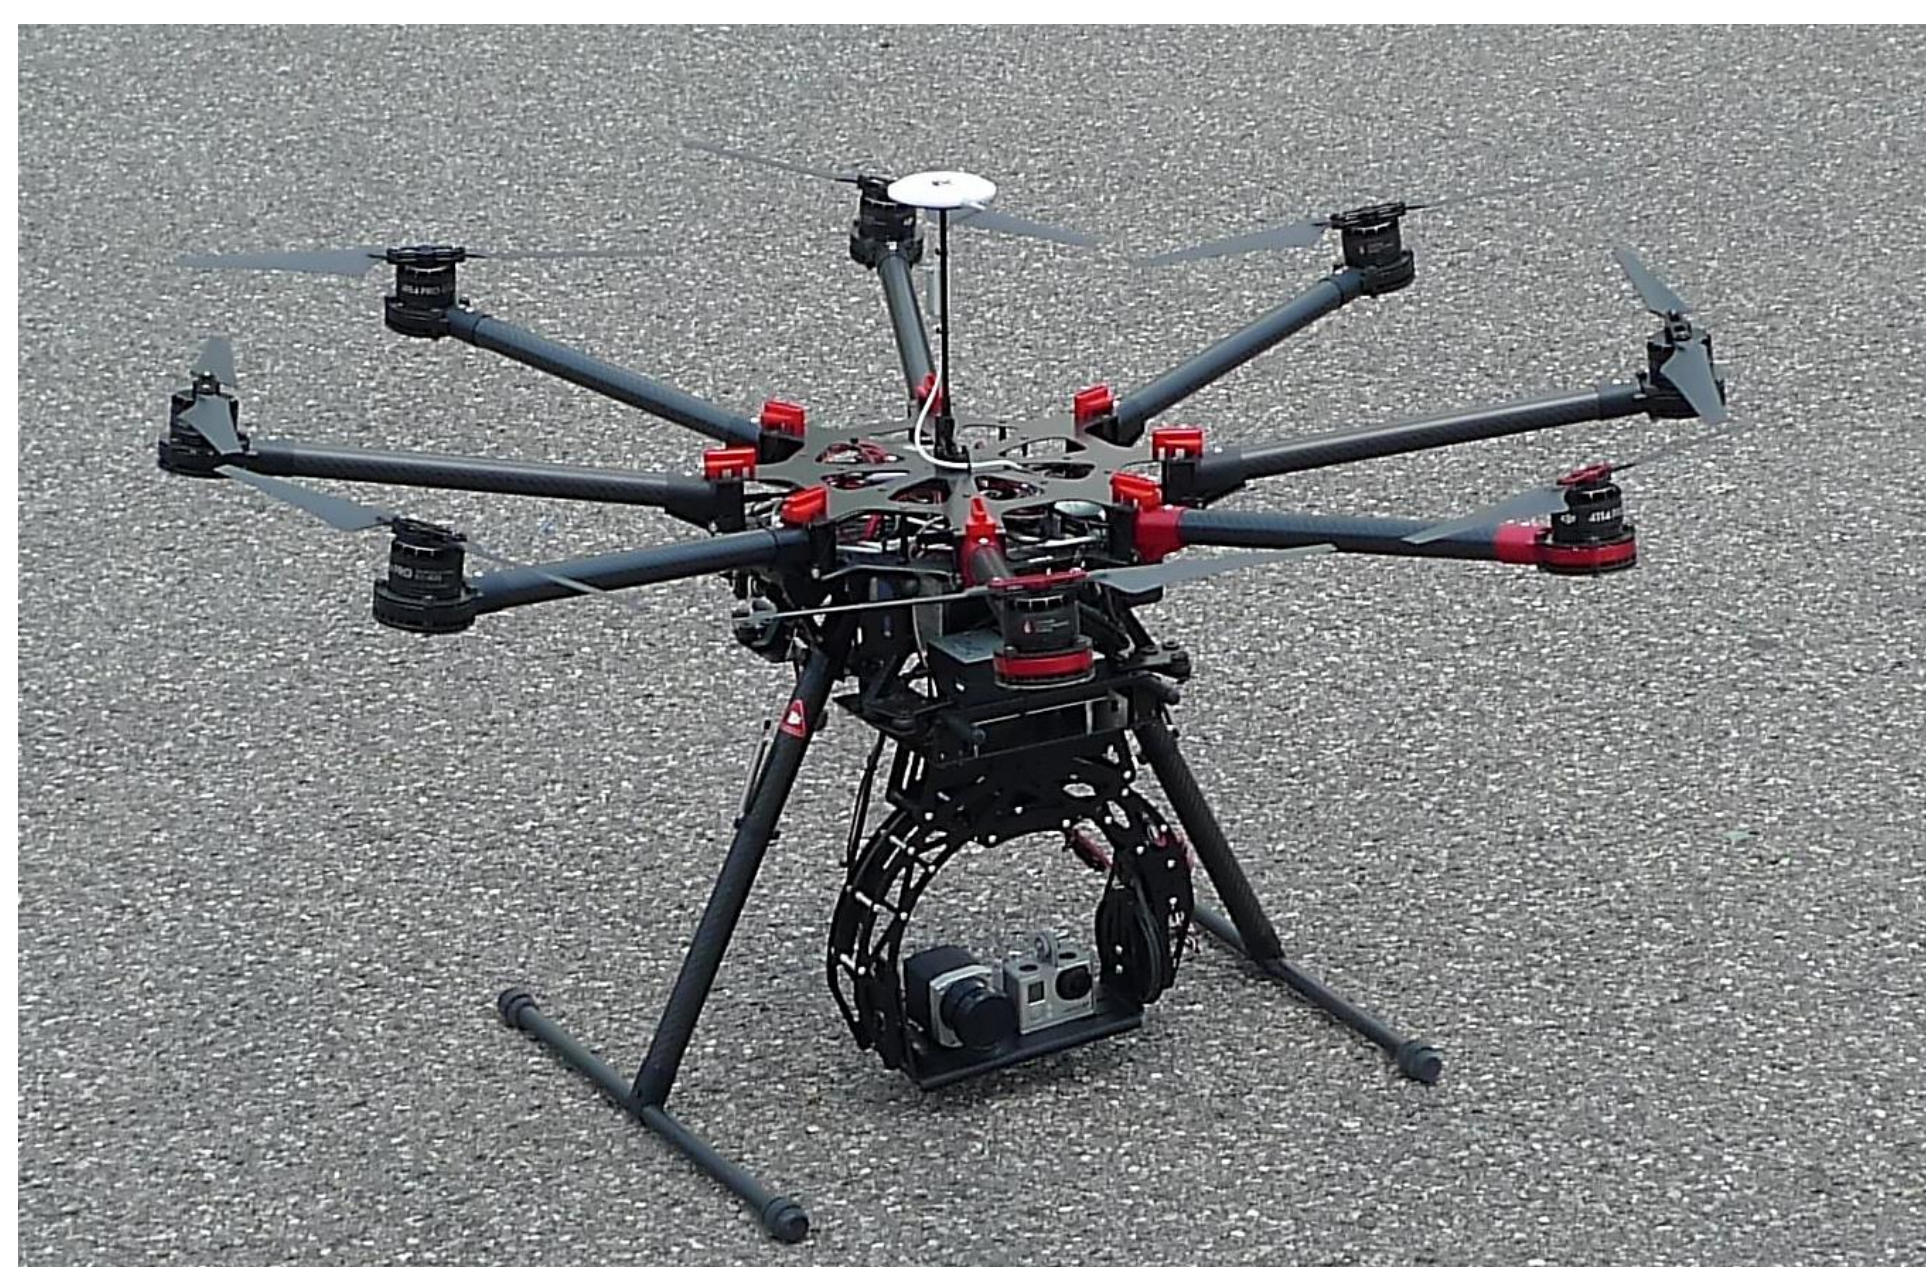
Fig. 1: PV LAB IR-multicopter drone; the take-off weight is about 7.5 kg.

The PV LAB drone system carries both (i) an infrared camera that records a thermal imaging video and (ii) a digital camera for comparison shots. Using this combination, PV module surfaces can quickly be monitored and defects easily determined and located. Fig. 1 shows the UAV ready to take-off.

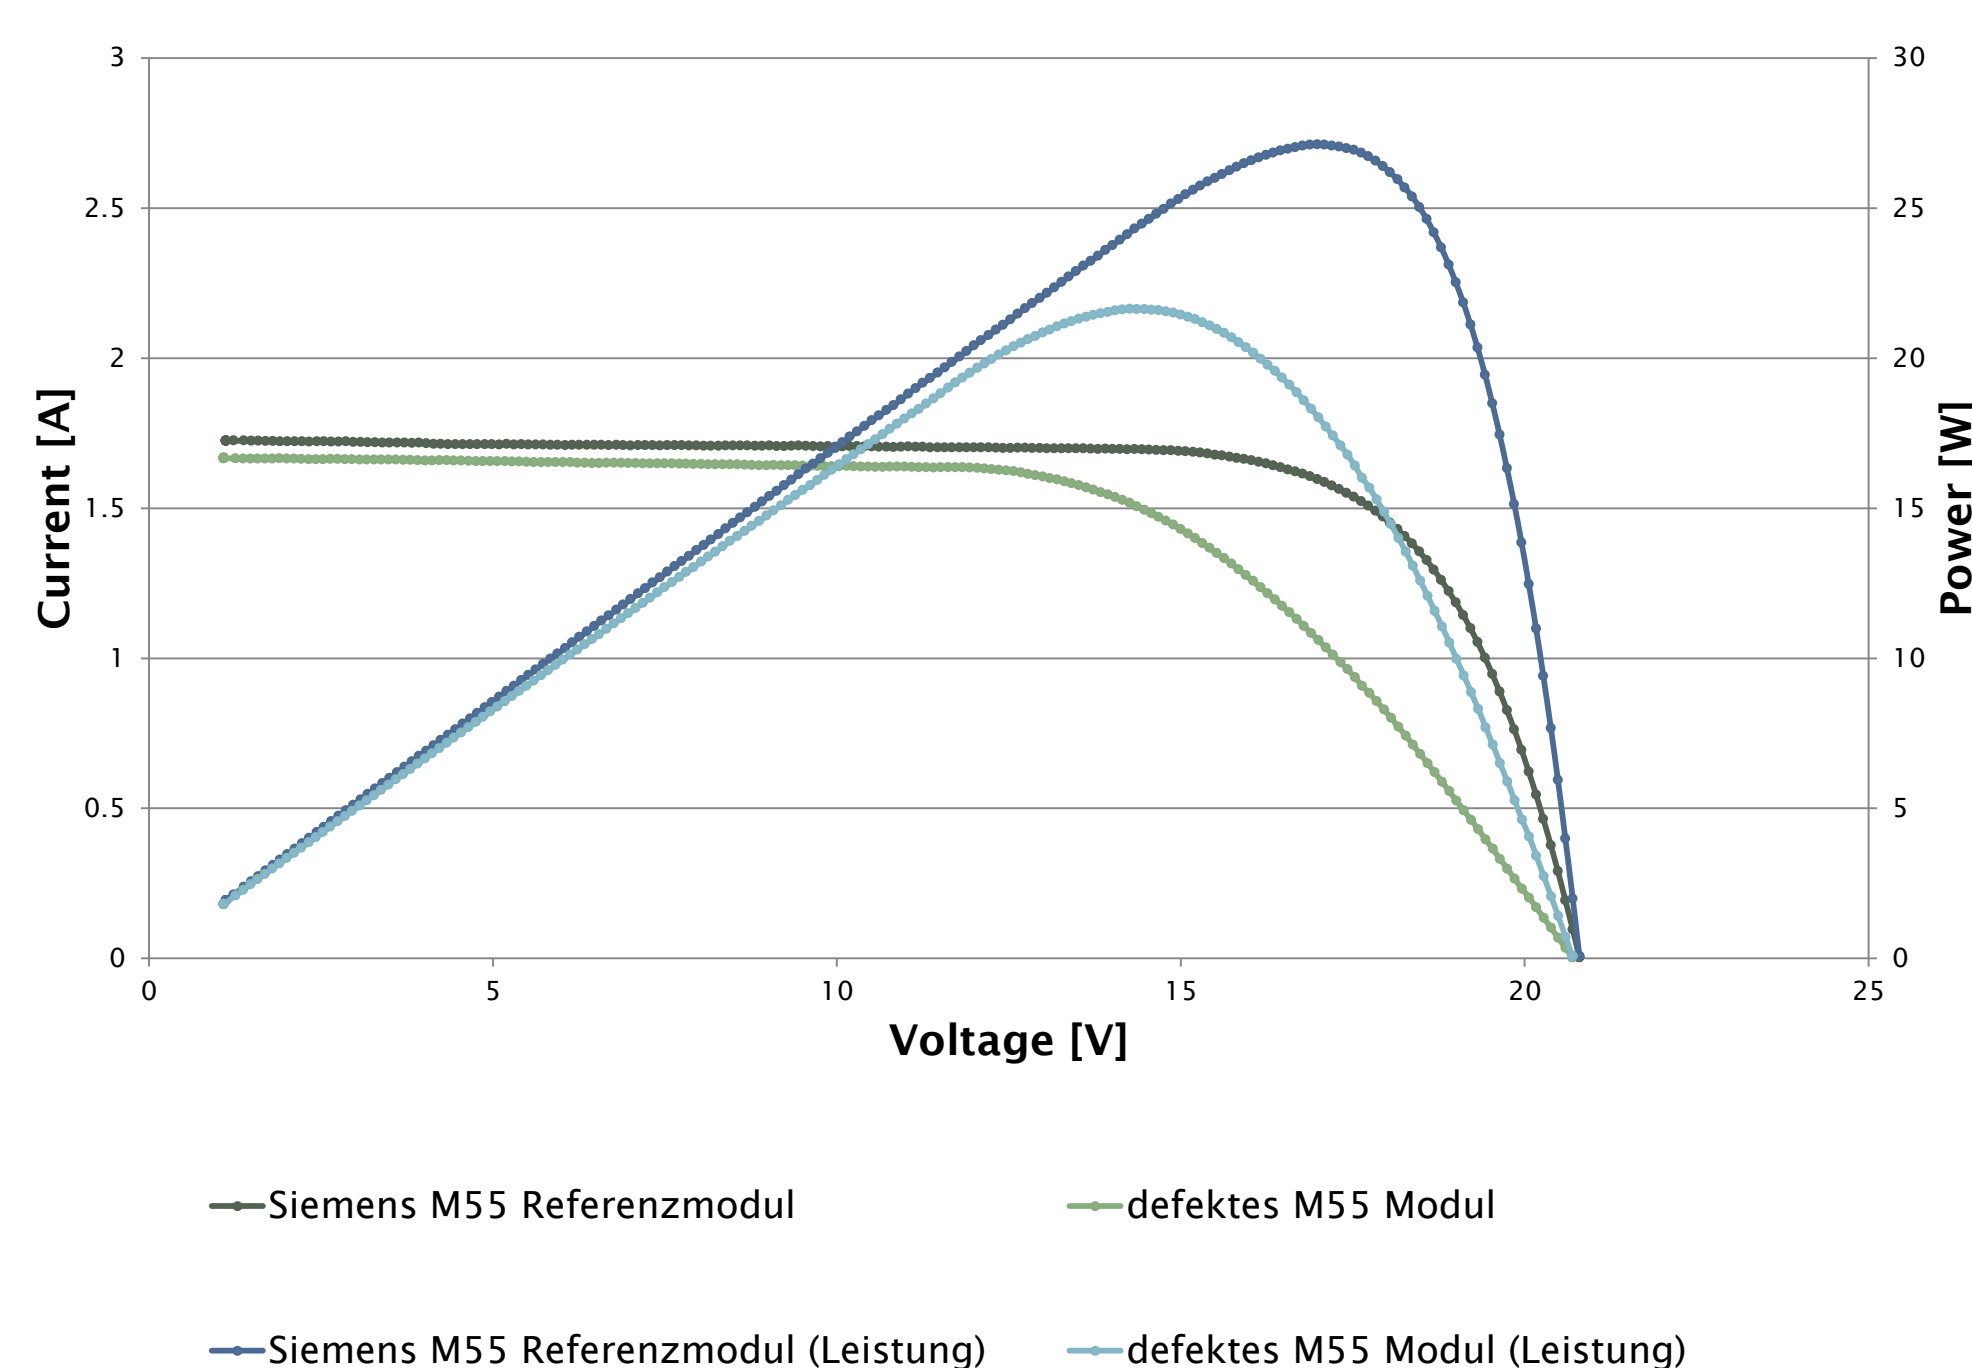
Fig. 3: Characteristics of the defective module (marked Siemens M55 module, Fig. 2)

Fig. 3 illustrates the power loss (of about 20%) of the module in Fig. 2.

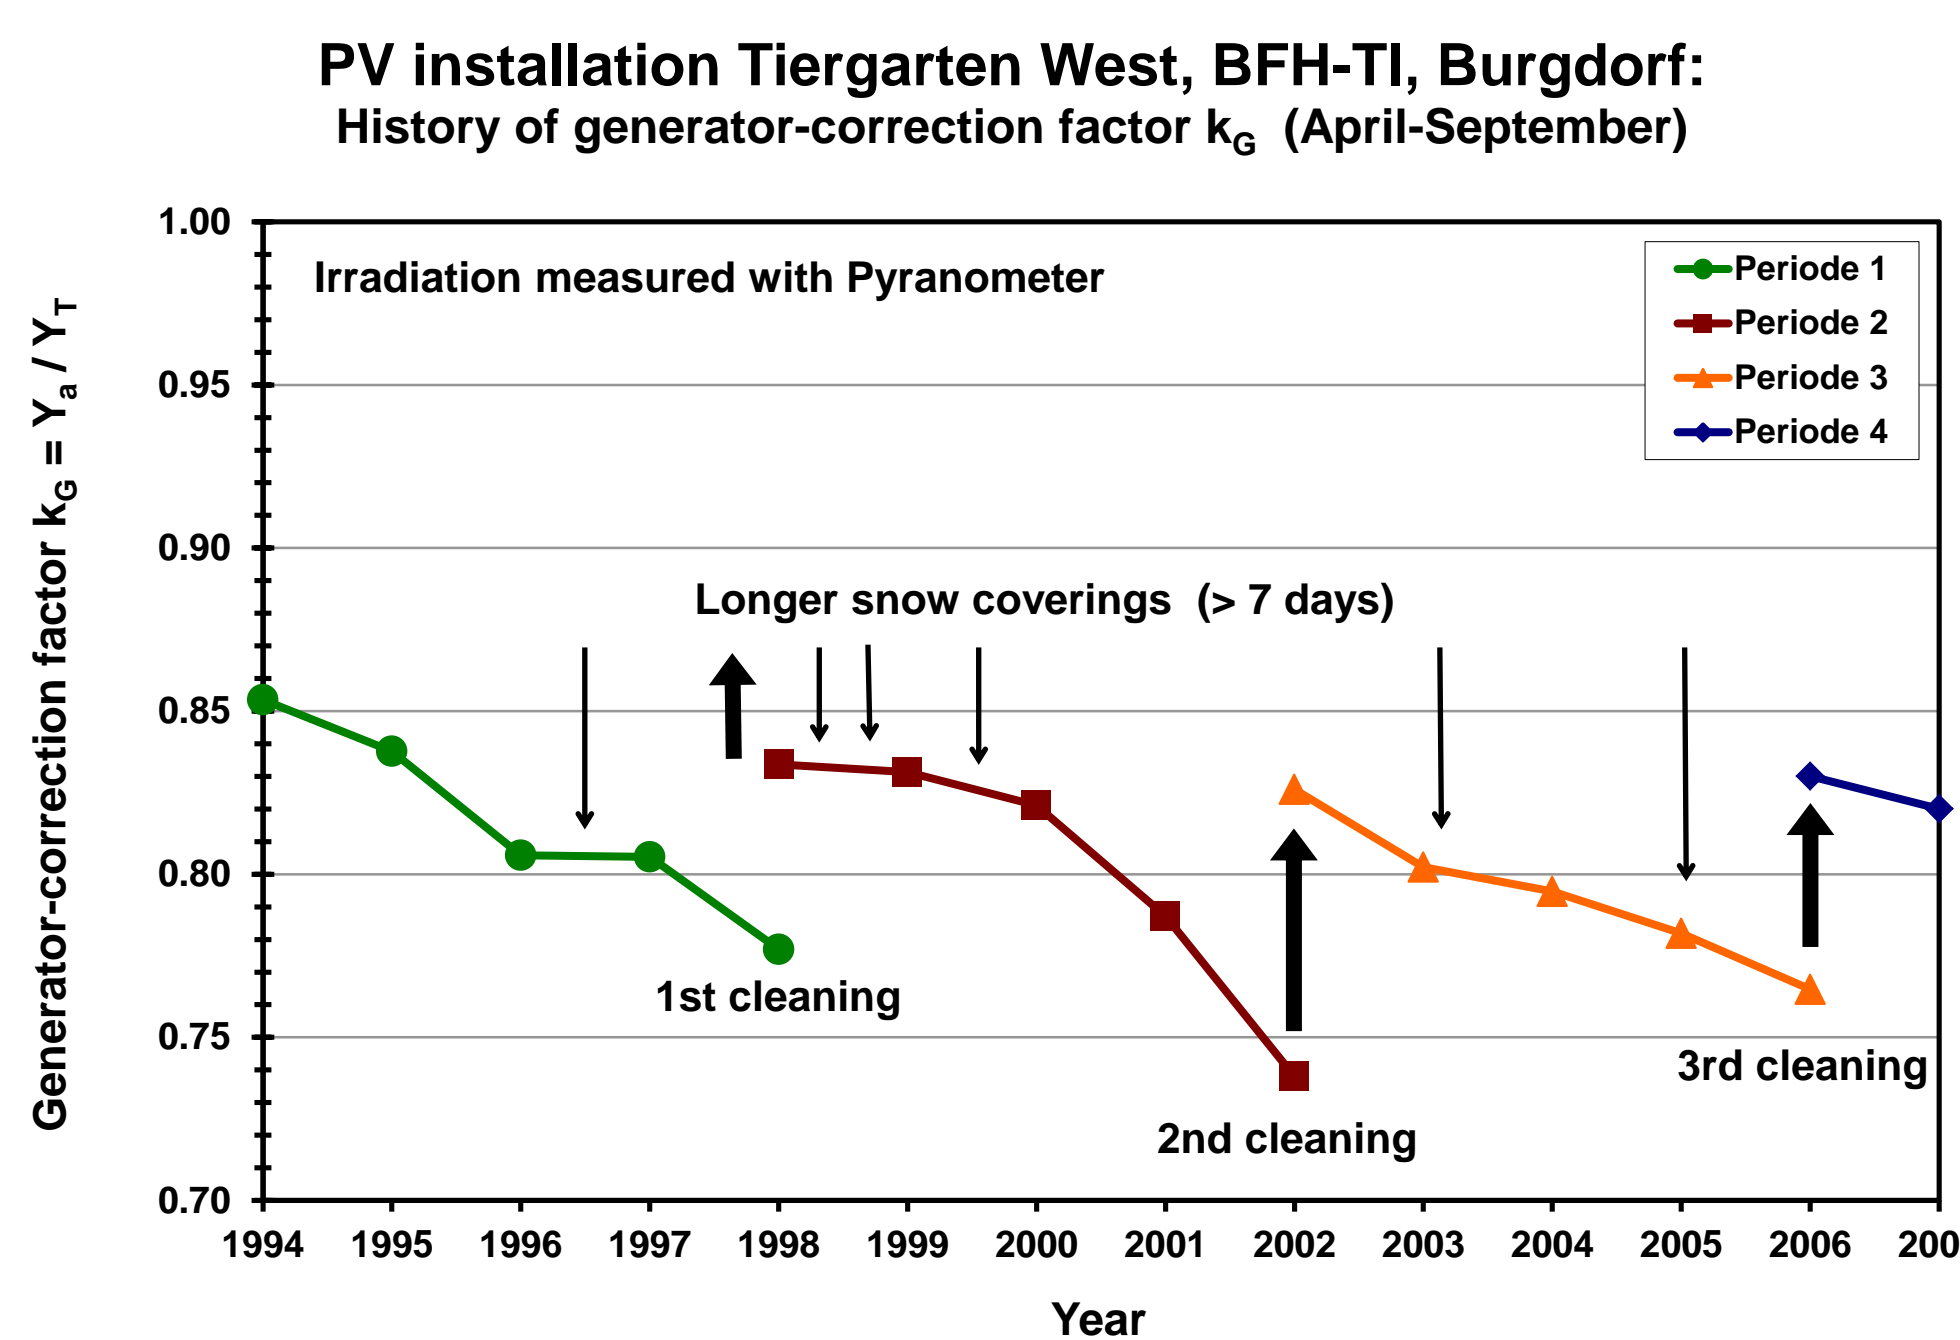
Fig. 4: Energy yield increase (1994-2007) of the PV installation at BFH Burgdorf due to cleaning.

As evidenced by PV LAB studies (e.g., examination of the PV plant on the "Stade de Suisse"), regular cleaning of PV modules increases the electric energy production. As an example, the Siemens M55 PV module surface, a 50 kWp installation on the roof of the PV LAB building at BFH in Burgdorf, is cleaned every four years. This results in a yield increase of 5-8% (Fig. 4).

The values in Fig. 4 are determined with the "generator correction factor"  $k_G$ , which is formed by dividing the "array yield"  $Y_A$  with the "temperature-corrected radiation yield"  $Y_T$  (Formula 1) and thus represents the ratio of the actual yield to the theoretical yield.

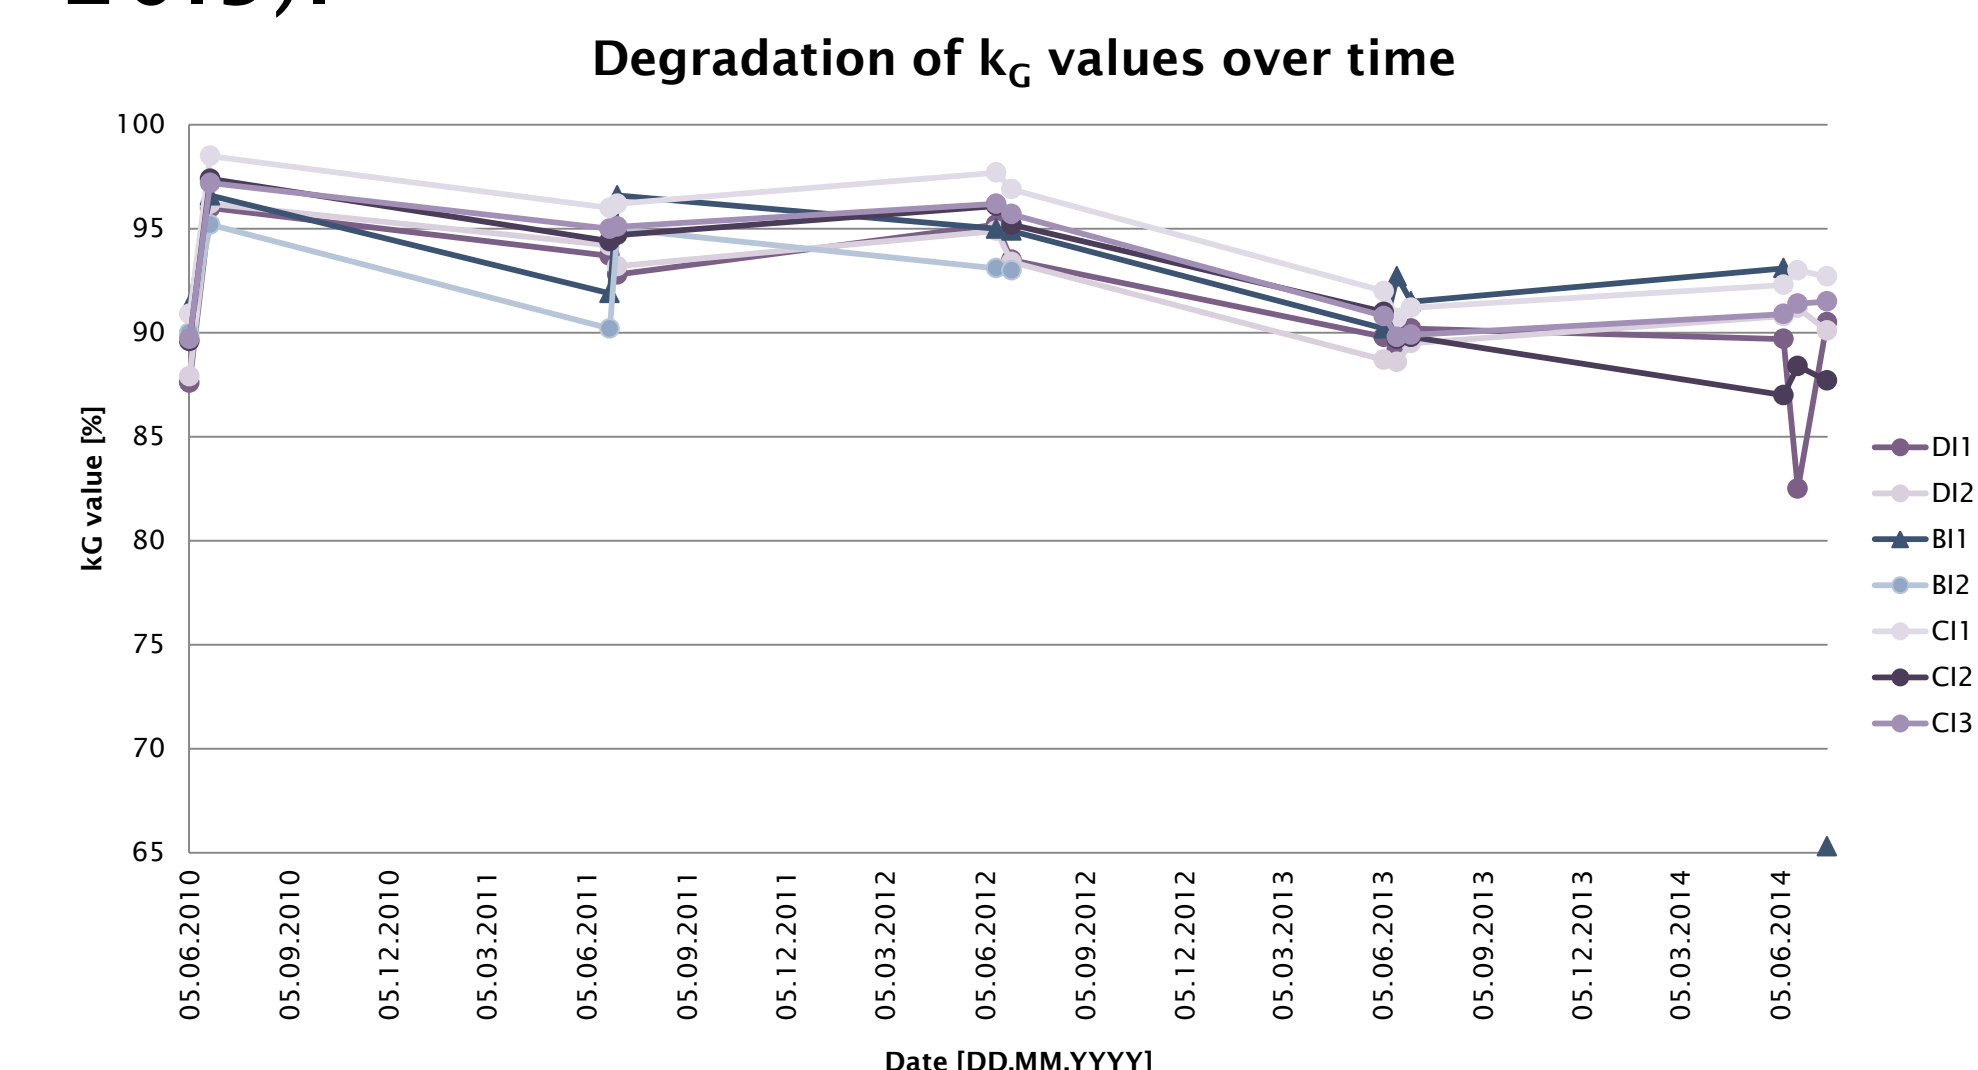
Fig. 5: Degradation of  $k_G$  values (2010-14) of the "Stade de Suisse" PV installation.

The degradation of the "Stade de Suisse" PV installation is displayed in Fig. 5. Cleaning the PV modules in 2015 (i.e., after 5 years of operation) increased the energy yield up to 4-5% (module inclination of 7 degrees). Cleaning the PV modules after 8 years of operation (also in 2015), increased the energy yield up to 6-9% (module inclination of 20.5).
