Methoden zur Fehlererkennung bei PV-Modulen und Anlagen – Qualitätssicherung im Feld

16. Nationale Photovoltaik-Tagung
Bern, Schweiz, 19. und 20. April 2018

Ulrike Jahn
TÜV Rheinland
51101 Köln, Deutschland
Ulrike.jahn@de.tuv.com

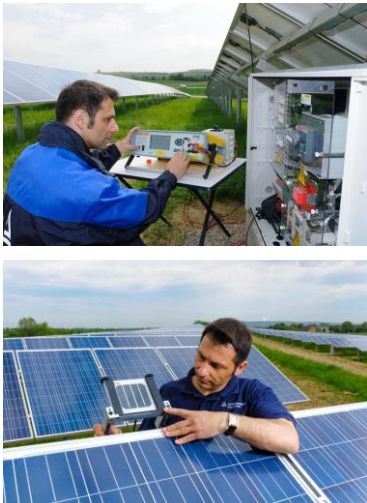
Measurement technique

- Performed with commercial **I-V curve tracer**
- Measurement of single PV module or a string of serially connected modules
- 4-wire connection between field terminal box and I-V curve tracer
- Other input channels for **irradiance sensor** and **module temperature sensor**, which are to be installed in the field.
- PV array measurements reveal **interconnection failures** of PV modules or detect **low power** of modules. But it but does not allow conclusion on output power of individual modules.
- This confirmation is possible with **mobile test centers** or shipment of samples to test laboratory.

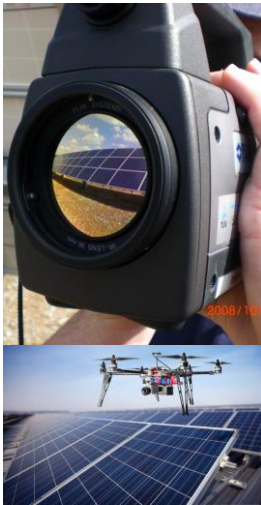
Introduction

- Infrared (IR) thermography is a well-established and powerful tool for the quality check of the PV installations:
 - Localization of failures that reduce the PV systems performance
 - Localization of abnormal heat generation
 - Proof of the quality of installation
- Today flying robots and drones for professional use are available on the market, which allow quick panoramic IR images. These can be used as basis for further analysis.
